i3V2.1 Feature list , REV.A 14th April 2016

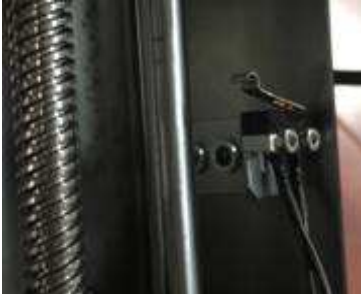
| I3V2 issue | I3V2.1 improvement | Pic |
|---|--|--|
| <p>I3V2 Z axis end stop has narrow contact with the gantry. Any deformation of frame would cause the mis-contact.</p> | <p>The new design place the end stop vertical to the gantry. So 100% touching ensured. And no protection tape is required.</p> | |

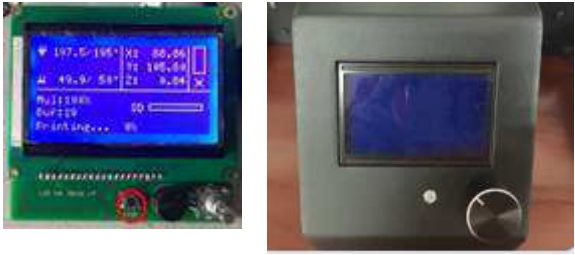
| I3V2 issue | I3V2.1 improvement | Pic |
|---|--|--|
| <p>No Reset Button</p> | <p>Hole at the housing enable the access to reset button.</p> | |

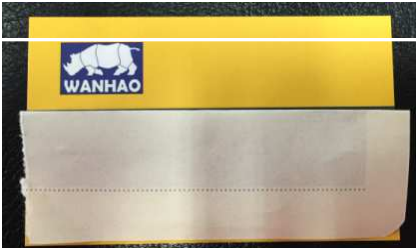
| I3V2 issue | I3V2.1 improvement | Pic |
|---|--|--|
| <p>No leveling card for leveling.</p> | <p>Include a card that is 0.1m for levelling (instead of using paper) and have the basic leveling instruction.</p> | |

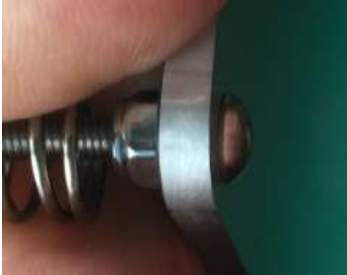
| I3V2 issue | I3V2.1 improvement | Pic |
|---|--|--|
| <p>The bed bolt move with the wing nuts, when move the wing nuts</p> | <p>Add the anti-slipping screw to secure the bolt. So there's no movment when turn the wing nuts or thumb screw.</p> | |

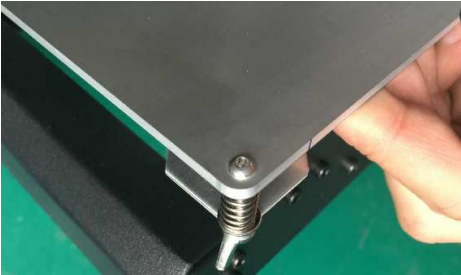
| <p>Bed with sharp edge, flatness tolerance +/- 0.3mm</p> | <p>New cutting way enable rounded edge. And more flat surface with tolerance +/- 0.2mm</p> | |

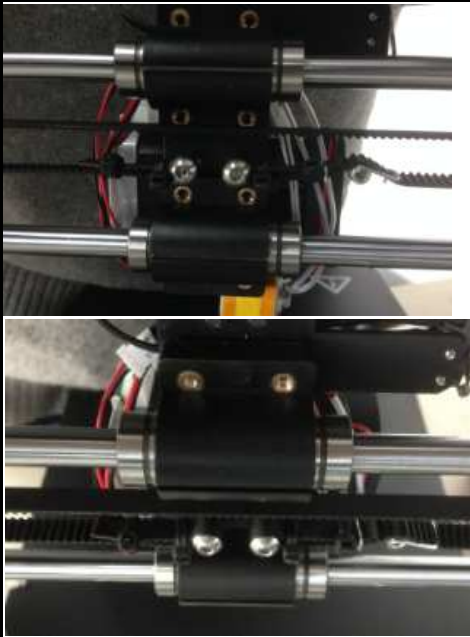
| <p>The steel bearing house with 17mm bearing rub the X axis belt. For long term running, it would cause some bad effect</p> | <p>The new plastic bearing house with 45mm bearing. First avoid rubbing the belt. Secondly it has better linear trace.</p> | |
