# 3D PRINTER

FILE NAME: OQD03201.doc  
REVISION : A

TITLE: How to fix i3 thermistor mal-function?

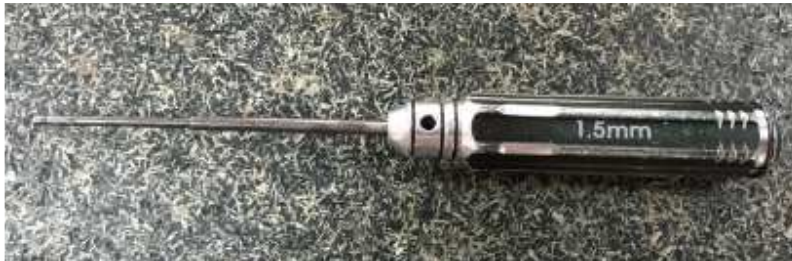
One piece 1.5mm hex wrench

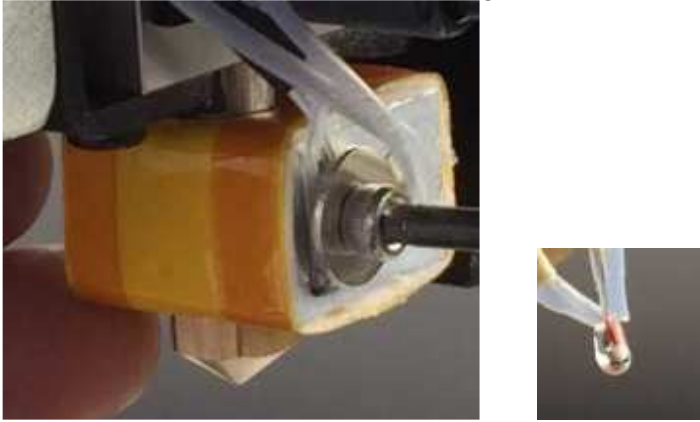
**4.1 Loose the locking screw on the hot end, so you can release the thermistor insulate cable.**

The thermistor was locked under one M3 screw. By release the M3 bolt, you can release the cable and one glass like thermistor which is used for temperature reading. Please handle with great care, do not drag or break the thermistor.

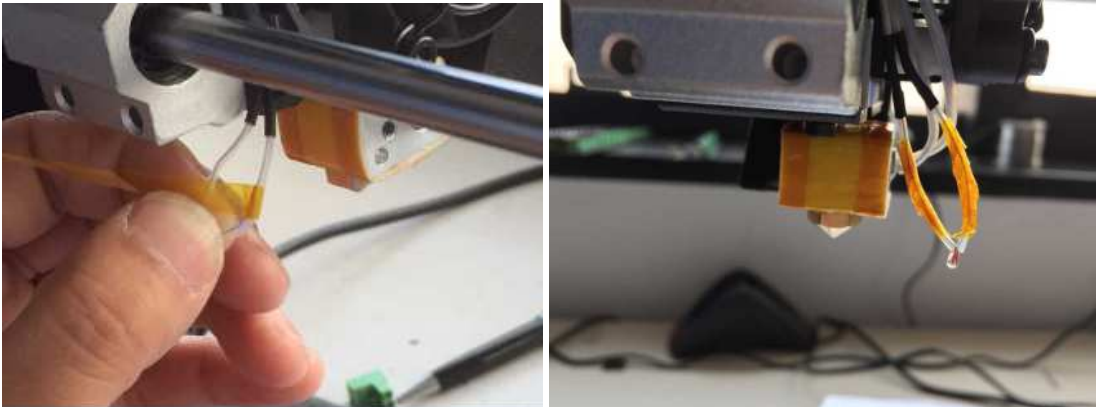
The insulating translucent cable may break under the locking screw and ring due to heat and pressure. So cover the cable by another insulate material would fix the problem. Kapton and Wanhao Masking tape are good insulate material.

A. To cover the broken cable by kapton tape.
