3D PRINTER

FILE NAME: OQD03201.doc
REVISION : A

TITLE: How to fix i3 thermistor mal-function?

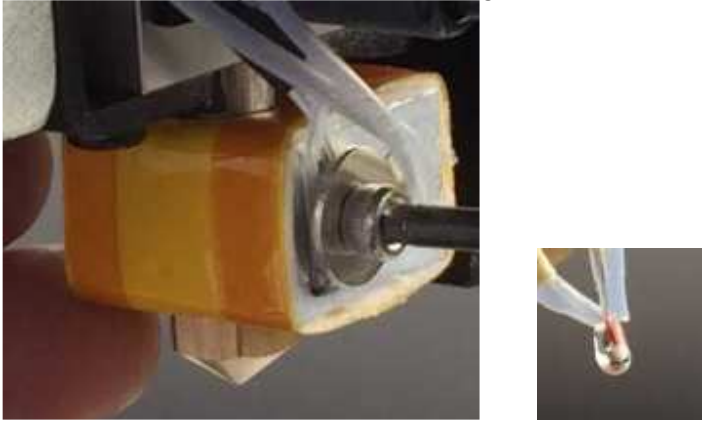
4.1 Loose the locking screw on the hot end, so you can release the thermistor insulate cable.

The thermistor was locked under one M3 screw. By release the M3 bolt, you can release the cable and one glass like thermistor which is used for temperature reading. Please handle with great care, do not drag or break the thermistor.
